***Report on the Response of Lake Barcroft Dam  
to Heavy Rains during the Period June 23  
through June 29, 2006***

**Lake Barcroft Watershed Improvement District**

**July 23, 2006**

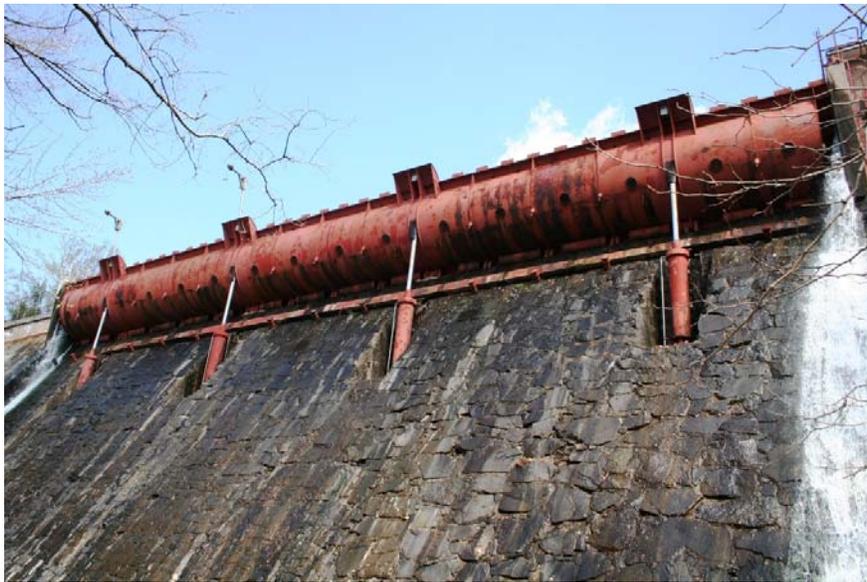
#### **LAKE BARCROFT DAM AND GATE**

The dam was rebuilt with protection against rising lake levels in the form of a 151 ft wide by 12 ft high bascule gate set into the top of the masonry. Four huge hydraulic rams (like arms) open and close the gate in response to a computer-operated monitoring and control system. The combination is designed to maintain the lake level

and essentially remove the risk of the dam failing in the manner it did during Hurricane Agnes. The picture, below, is the dam and its hydraulic rams seen from downstream.
